*Cadillac* **SERVICE ROUND TABLE**

**SERVICE SUMMARY**

**THE GRAY LIGHT  
OF DAWN**

**... a discussion of "booms" and vibrations**

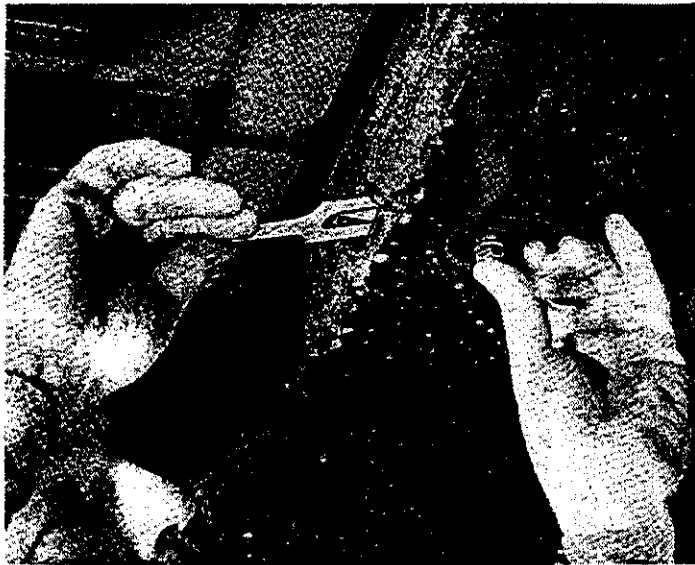
#### 5. Custom Align Prop Shaft as Required

Once we have aligned the prop shaft using the special gage set, we are ready to customize this alignment to the standing height of the particular car we are working on. To do this, refer to the chart on page 7-13 of the 1962 Shop Manual, and determine what shims need to be changed in order to customize the vertical alignment. Once these shims have been changed, of course, the alignment will no longer match-up to the measurements made by the alignment gages. In fact, the alignment gages can actually be removed before customizing the vertical alignment, since we have no further use for them. After customizing, the prop shaft is in proper alignment for the smoothest possible operation with a three passenger load.

This alignment is usually satisfactory with the driver alone, or with a six passenger load. However, if the owner drives alone most of the time, and he wants the best possible alignment for that condition, we can further customize the alignment by removing a 1/16 inch shim from under the prop shaft center bearing mount . . . or, if you are all out of shims at this point, by adding a 3/64 inch washer under each of the two legs of the rear motor mount. On the other hand, the owner may want the best possible alignment for a six passenger load (or possibly his trunk is always heavily loaded). This would be quite rare, however, since the ride with only one passenger would be less than desirable. However, if this is the case, an extra 1/16 inch shim can be added under the center bearing mount.
